Dream Home Consultants, LLC.

CONFIDENTIAL INSPECTION REPORT

15487 W. Sample Avenue, Phoenix, AZ

10/11/2007 8:00 am to 11:45 am

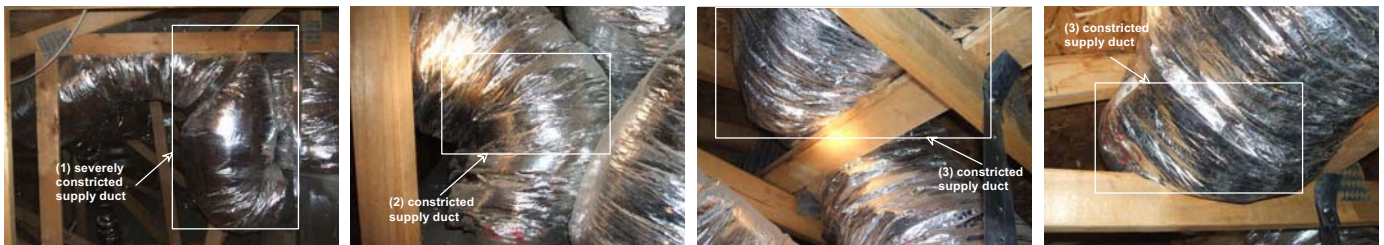
1

We observed constricted flexible ductwork. This condition can reduce air flow, cause poor system performance, increase operating costs, and reduce system useful life. Flexible ducts should be installed according to industry standards as described at www.flexibleduct.org. We recommend repair of all constricted ducts by a qualified HVAC contractor who is knowledgeable about the previously described industry standards. The duct(s) requiring specific attention include: (1) a supply duct leaving the front of the left furnace supply plenum is severely constricted by an S bend as the duct leaves the plenum; (2) a supply duct leaving the top of the right furnace return plenum is constricted by a hard bend as the duct leaves the plenum (3) a supply duct leaving the top of the right furnace supply plenum is constricted by an S bend as the duct leaves the plenum and is constricted in several places by being stuffed between truss webs above the service platform; (4) a return duct in the left attic is severely constricted by a bend across a truss web as the duct enters the boot and is severely constricted by being partially crushed near the boot; (5) a supply duct serving the left rear living area is constricted as the duct runs through roof sheathing and is constricted by the weight of another duct on top near where the duct runs through the roof sheathing; (6) a supply duct in the left/rear attic is severely constricted by being crushed at a double truss.
